Social Audit on Improved Railway Infrastructure, Passenger Safety and Amenities on the Mumbai Suburban Rail Network

Social Audit Survey of Mumbai Suburban Rail Network

Carried out and Reported by
Hong Leanne Truong & Ricky Vella

July 2015

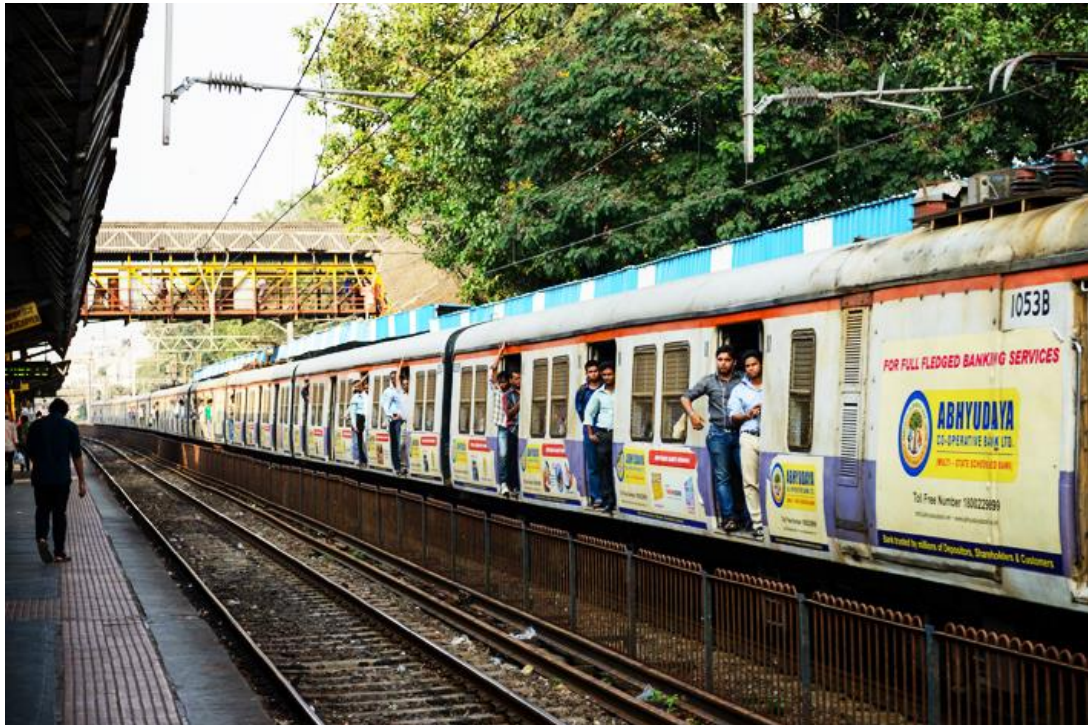
The current infrastructure falls hopelessly short of catering to the heavy density of passengers during peak hours. This has forced commuters to resort to dangerous, life-threatening alternatives. Thousands of commuters can be seen putting their life and limb in grave danger by riding with their feet precariously over the edge of the foot boards of the coaches.

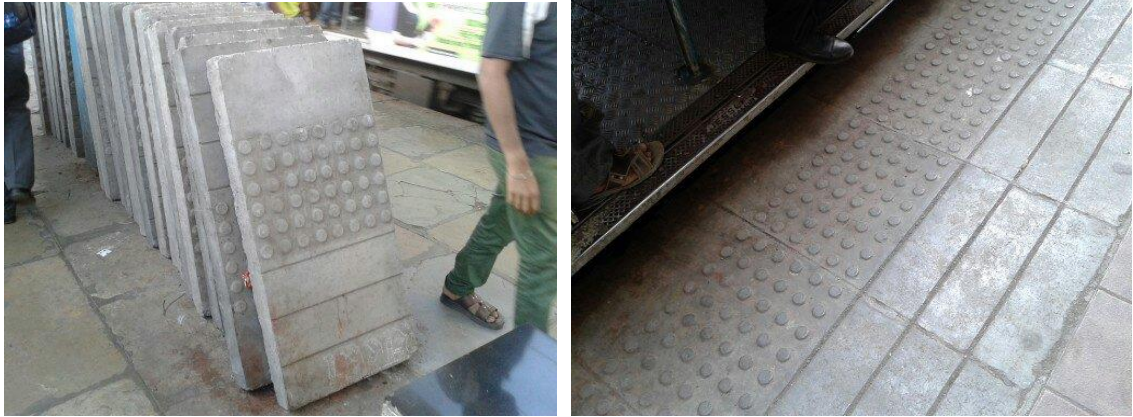
As per the Railway Schedule of Dimensions, the platform height from the top of the track rail is to be between 760mm and 840mm. With the floorboard level of suburban railway coaches being close to 1,200mm, the vertical gap has been between 360mm and 420mm, sufficient for a commuter to slip into and be injured or even get killed. Following a public outcry, the PIL, a media campaign and a *suo moto* High Court intervention, the Railways were forced to expedite minimising this gap by raising the level of the platform. A level of 920mm has been considered to be the maximum safe level and accordingly, in response to the Court Order, both WR and CR have undertaken to raise all platforms of all stations on the MSRS. This is being done by placing the edge precast concrete slab of about 1200 x 600 x 100mm thick, having circular projections to prevent skidding as shown in the pictures below. It was assumed for the purpose of the audit that whichever platform edge has been provided with these slabs, those platforms have been raised to the required levels. This does not mean that platforms raised by other tiles prior to the Court Order did not meet the criteria of the requisite height but those platforms have not been included in the audit. Dadar WR platform number 4 is one such example. A point to note is that despite raising the platform height, the vertical gap is still as much as about 300mm.

New Concrete Slabs

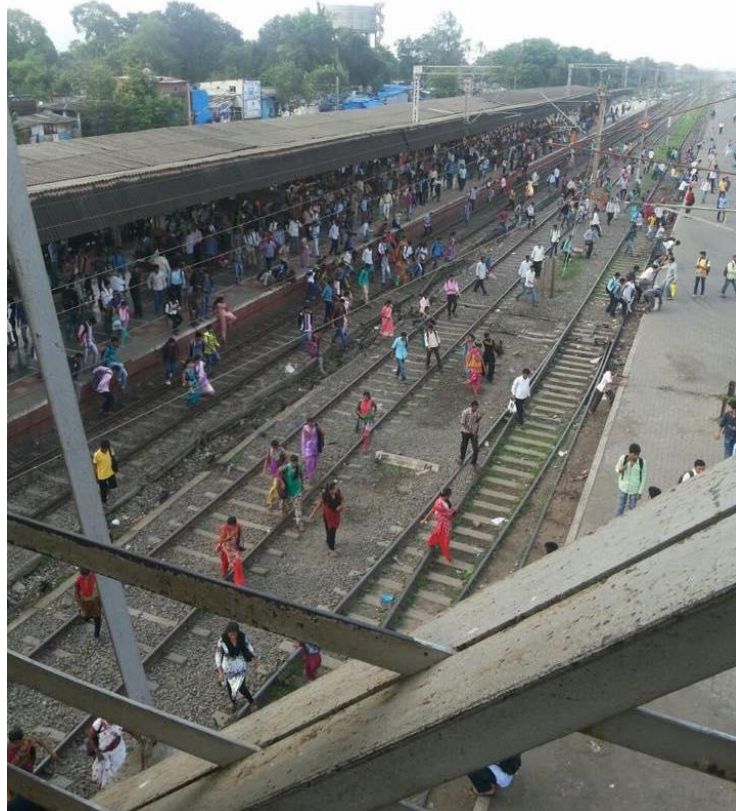
4.4 Railings between the tracks to prevent crossing were not present at Lower Parel, Central Dadar, Parel, Sandhurst Road, Bandra, Ghatkopar, Mumbra, Kalyan, Diva, Nerul, Kanjurmarg, Boisar & Virar stations i.e. 57% of stations that require the railings do not have them (13 out of 23). This means that only 43% of stations that require fencing have the railings to prevent commuters from crossing (10 out of 23). However, even where present, the railings are found inadequate as they did not extend the full length, such as at Thane, Kurla stations, or they had random gaps in the fencing, such as at Borivali station. This makes it easy for commuters to climb over the railing or walk around them. In any event, the height is inadequate, as discussed below in the recommendations.

Lack of railings enables crossing of the tracks at Boisar Station

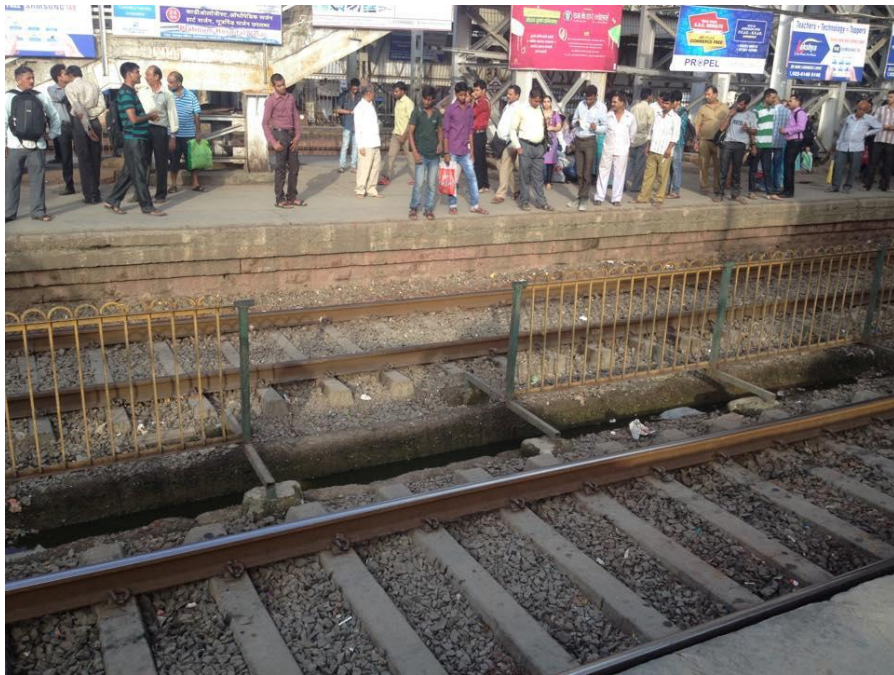
Opening in railing at Borivali Station

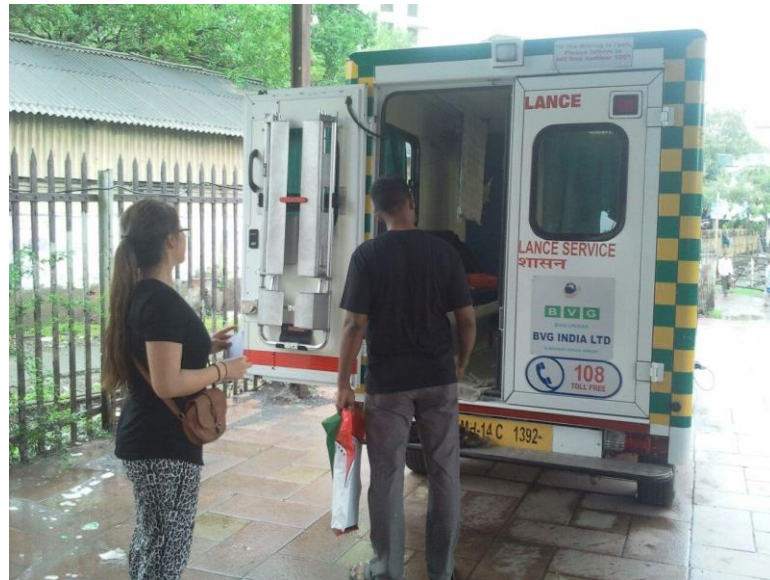
4.6 Emergency Ambulances were found parked outside at Churchgate, Lower Parel, Central Dadar, Parel, CST, Wadala, Bandra, Andheri, Ghatkopar, Thane, Mumbra, Kalyan, Kurla, Mankurd, Vashi, Nerul & Borivali Station i.e. 63% of stations had ambulances parked outside the premises.

Ambulance at Lower Parel Station

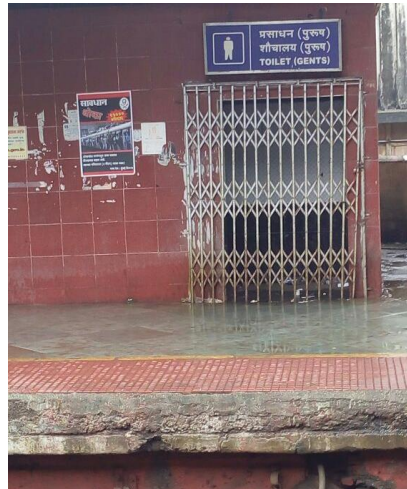
4.15 The quality of sanitation of the toilets was found to be extremely poor at all stations and were stinking. The toilets were found locked on some stations.

Locked toilet block at Mulund Station on Platform 4

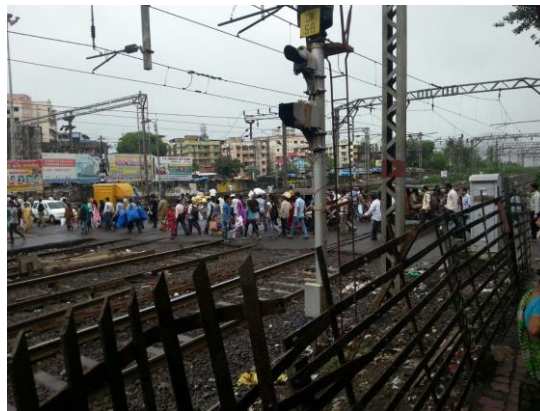
5.2 All entrances to station property must be official. Any unofficial entrances should either be closed or should be made official. E.g. at Kalyan, there are 6 official entrances and 4 unofficial entrances. At Diva, the only entrance is an unofficial one. There is a cement level crossing, which the public and commuters must use to enter or exit the station. This means that the Municipal Corporation has basically demanded risky behaviour from commuters, which is completely unacceptable. Two official FOB entries must be built for the public and commuters. The end of platforms should be blocked off so people cannot cross the tracks in the current manner.

Cement crossing found at Diva

Furthermore, we also saw cars crossing the tracks at the level crossing. A Railway official mentioned that this crossing must be shut down since as there a bridge just 3-4 km away.

5.3 However, if the cement level crossing is to be retained, more safety precautions are necessary. For example, trains entering the station must slow down to 15km/hr; just sounding the horn is insufficient and shows a disregard for human life. Furthermore, the railways should be more proactive in stopping people from crossing the track when trains are approaching.

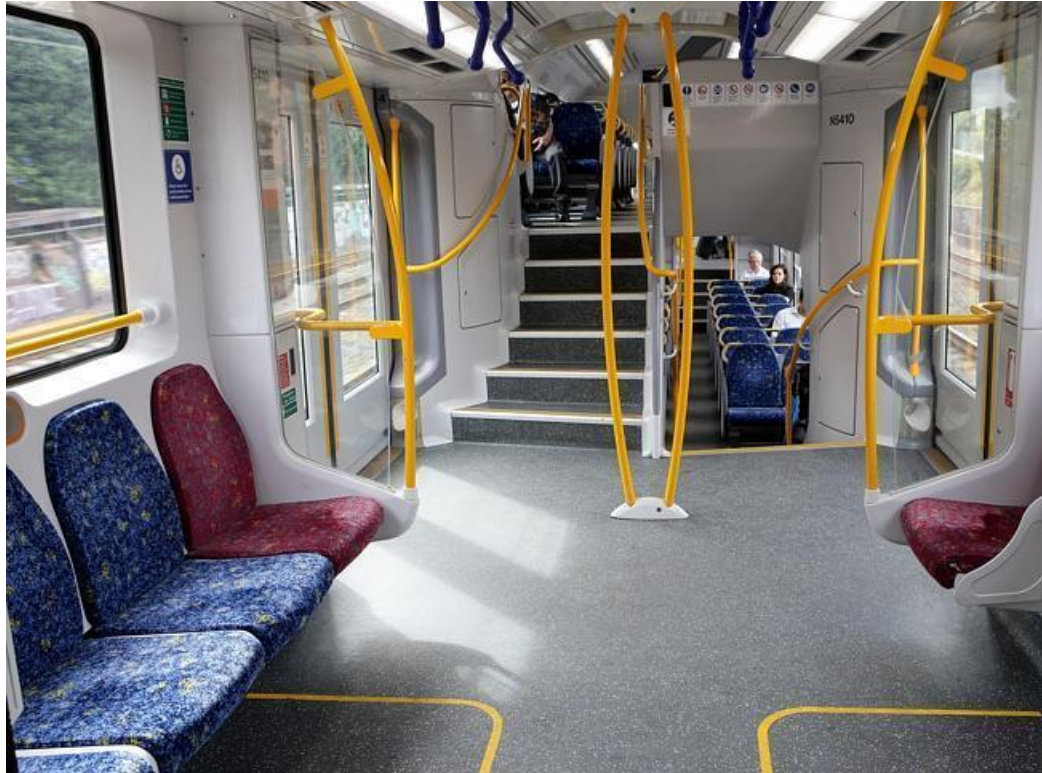
Layout and design of Sydney double-decker train

Inside a Sydney double-decker train

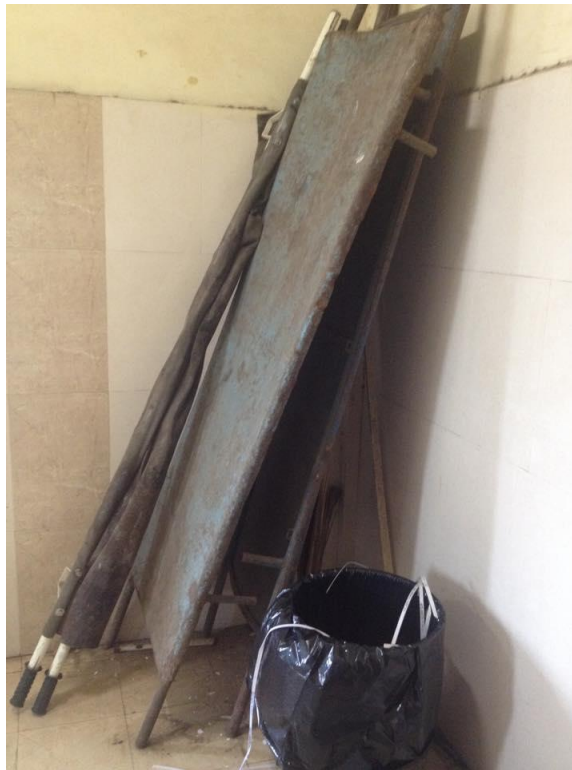
5.18 Stetchers must be maintained properly and must meet requisite hygiene standards. E.g. at Nallasopara Station, the metal stretchers had dried blood on it. This can be potentially deadly for those injured with open wounds.

Stretchers at Mumbra Station

5.19 Stretchers must be of uniform material at all stations; instead some stations have metal stretchers while others have fabric stretchers. Stretchers made of lighter, strong and rigid materials such as FRP or aluminium are desirable. Use of flexible stretchers to carry accident victims can cause further harm to them during transportation.

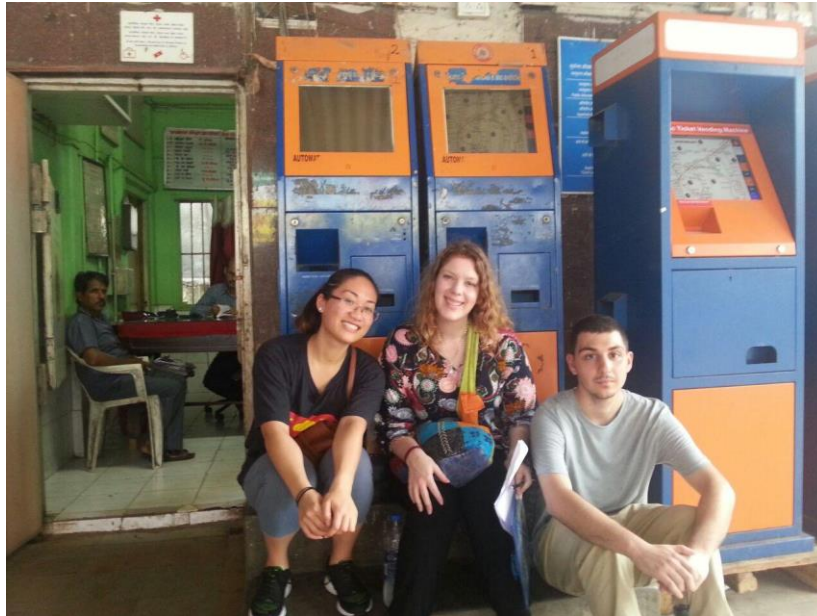
AVTMs at Mumbra Station

5.25 Instruction sheets should be placed on the side of ATVM machines for those who have no knowledge of usage of ATVMs as our general understanding is that ATVMs are quite a new phenomenon for commuters.

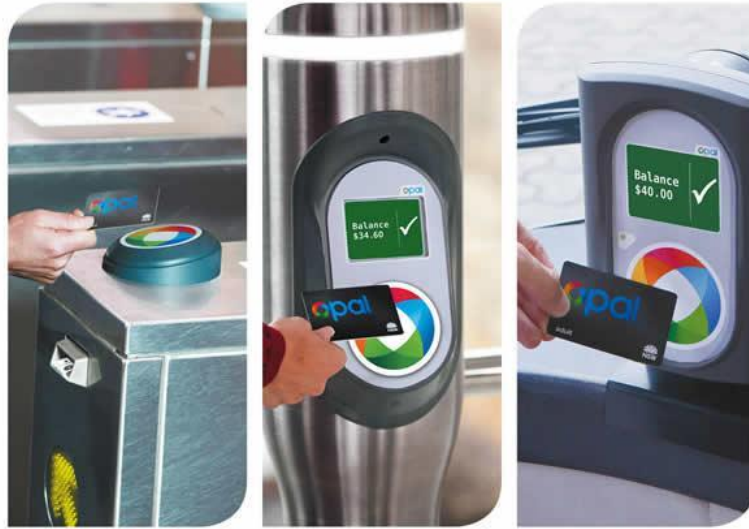
OPAL Card System in Sydney Australia

5.27 In Sydney Australia, we use OPAL cards, which can be topped up at certain retailers or even topped up online. At each Sydney station, there is an OPAL card reader where individuals “tap on” when they enter the station, and “tap off” when they reach their destination. The fare is calculated based on the distance travelled and this has greatly increased the efficiency of railway operations by reducing the need to have people in the ticket offices as well as having the effect of reducing the time needed for commuters to line up and purchase tickets. Consider the potential this system of purchasing tickets can have on the efficiency of the MSRS.

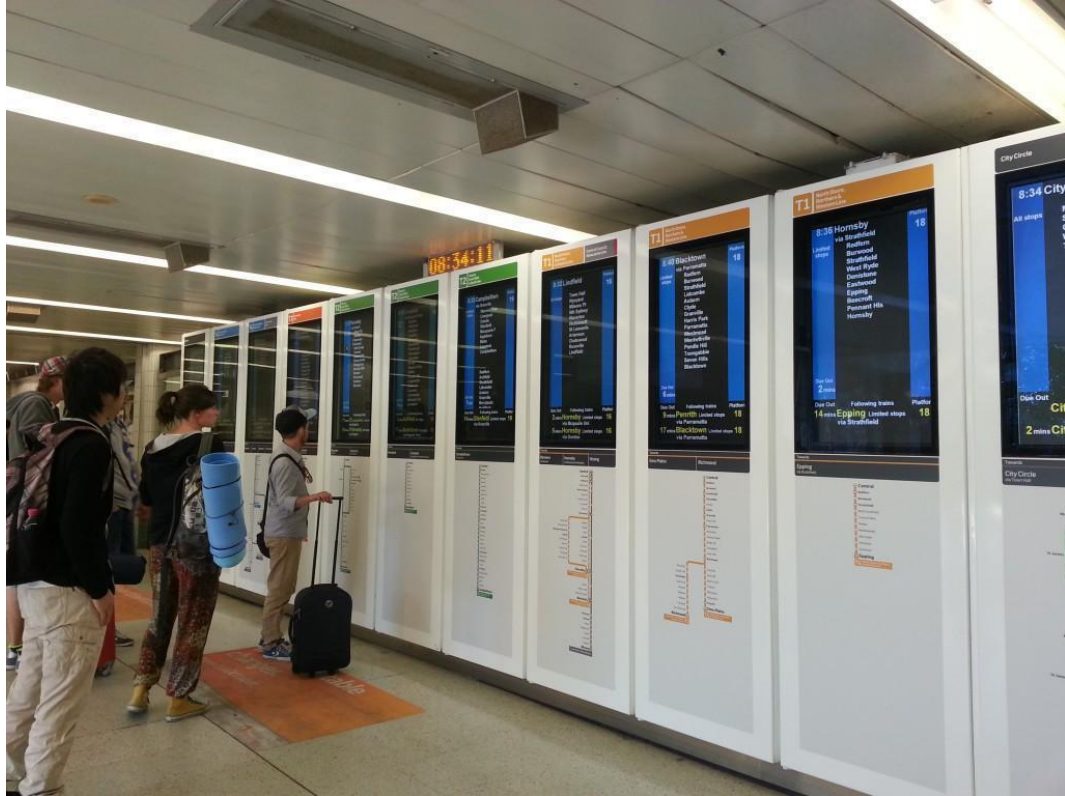
Indicators at the entrance at Sydney's Central Station

5.38 All entrances should have a sign that displays the station name clearly. All entrances should have signage to impart information regarding the location of various facilities such as Ticket Booking Office, Toilets, Station Master's Office, Escalators etc. All entrances should also have signage for quick access to information. For example, in Sydney Australia all entrances have boards that show which trains are going to which platform (please see below). This decreases inefficiency and allows commuters to know exactly which platform to go to and which train they will need to catch.

5.39 The above signs must also be placed in all FOBs so that any commuters changing lines are aware of where they need to be going. This will decrease travel time, as currently commuters must go to the entrances to look for signs regarding which platform they should be on.

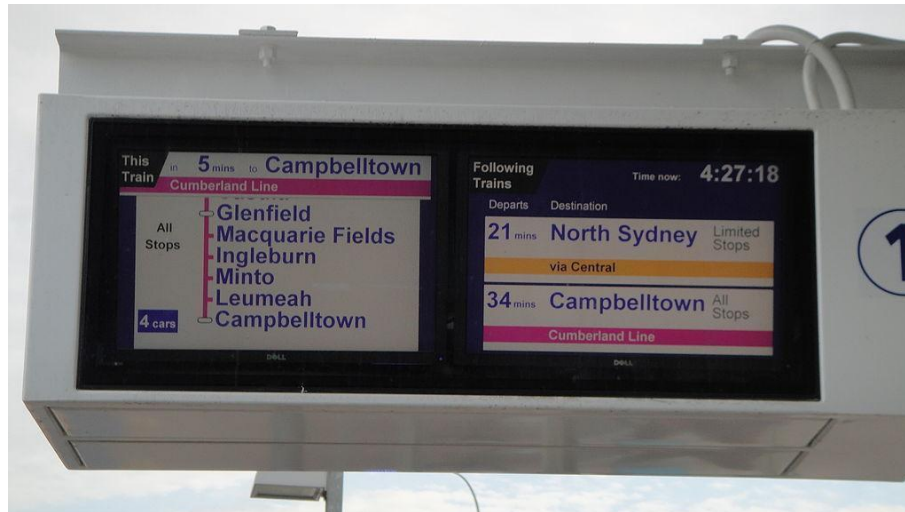
Platform indicators on all Sydney train platforms

5.41 Signboards should also be present on all platforms. Current signboards have Hindi on one side and English on the other. This is extremely inconvenient for commuters, as they need to walk around to the other side. Instead, Hindi and English signboards can be made to alternate. In Australia, there are roughly 3-4 signs boards, like the ones below, that are spread out along the platform. We suggest these signs along all platforms. Please refer to this video: <https://www.youtube.com/watch?v=z8BwYYGM6M>

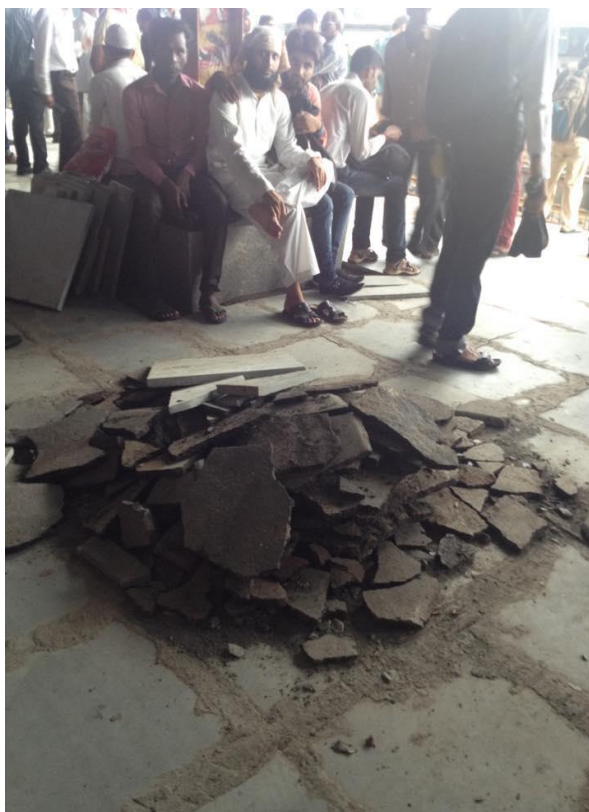
5.43 In the event of construction, loose tiles, water puddles, depressions or raises in the platform height or any other such hazards, signs should be put out to warn the public. However, if signs are insufficient e.g. a large area of loose tiles or depressions in the ground on the platform, that area should be cordoned to avoid tripping or slipping.

Hazardous Construction at Borivali Station

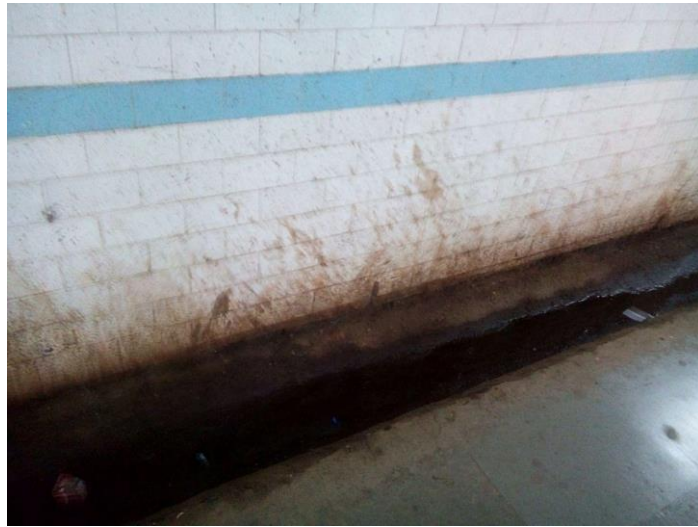
Hazardous & Unhygienic Subway at Dahisar

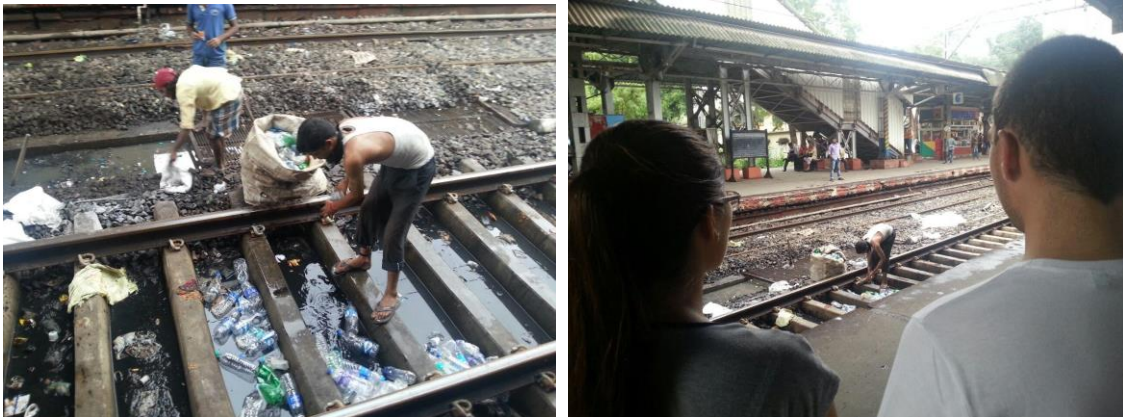
Cleaning the tracks at Kalyan Station

5.48 There should be trash cans placed at regular intervals on the FOBs and the platforms. During our audit, we found very few bins so we had to carry our trash quite a distance. The few bins we found were poorly maintained and so full of garbage that it had evidently not been emptied for a few days. Cleaners should be required to empty the trash cans regularly.
