# Study On The Accessibility and User-Friendliness *of* Mumbai Metro Aqua Line (Line 3)

Agamyia Jain and  
Mihika Omseema

July, 2026

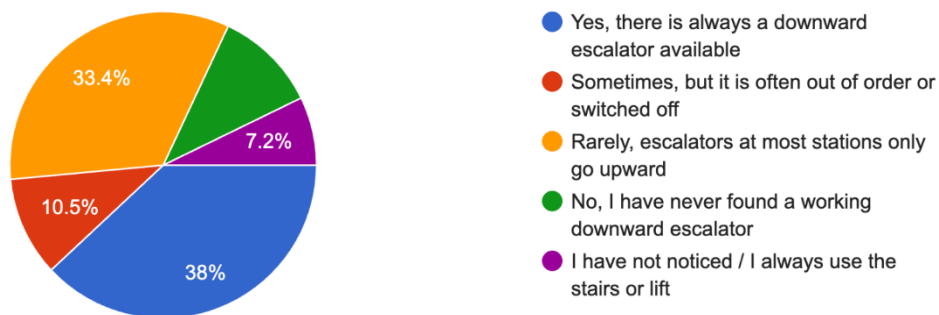
When entering a Metro 3 station, can you find a working downward escalator? This applies when you are going down to the platform level to board a train.

Survey responses indicate that over 50% commuters experience difficulty finding downward escalators when entering Aqua Line metro stations. This is consistent with observations made during field visits, where only 20% exits were seen to have downward escalators. The results suggest that commuters are often required to rely on lifts or staircases, increasing the physical burden of entering and exiting stations.

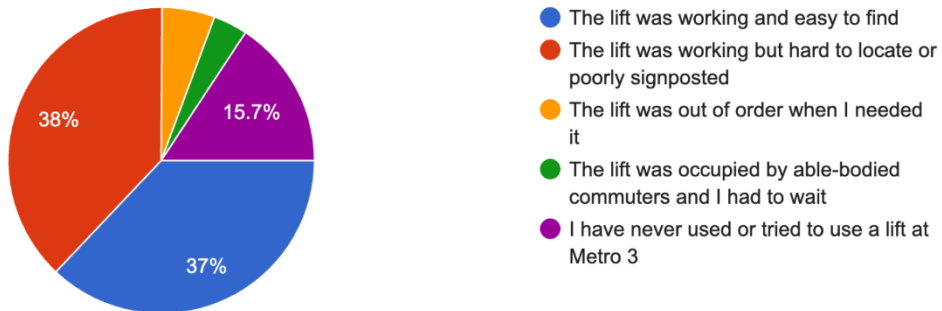
When you have used or tried to use a lift at a Metro 3 station, what was your experience? Select the option that best describes your most recent experience.

While many respondents reported that lifts were operational when required, a majority indicated that they were difficult to locate due to inadequate signage, while others reported encountering lifts that were out of service. This issue is particularly significant for first-time or infrequent users, as information regarding lift availability is generally provided only within station premises. Consequently, commuters approaching a station from the street are often unable to determine which exit is equipped with a lift. However, it was observed during the field assessment that some stations, including Cuffe Parade, Vidhan Bhavan and Bandra Kurla Complex, have recently installed external signboards indicating the availability of lifts

and other accessibility features at specific exits. Expanding such signage across the network could significantly improve wayfinding and accessibility for commuters who rely on lifts.
